RF1037200

Bon Jour Unplugged Base assembly with new battery kit

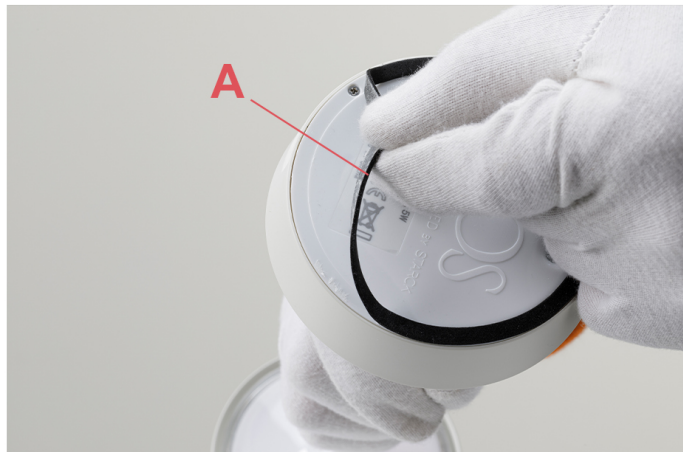
Fig.1

Remove the base assembly with battery kit:
It's necessary to remove the rubber pad (A) from underneath the lamp base.
Unfasten the three fixing screws (B).

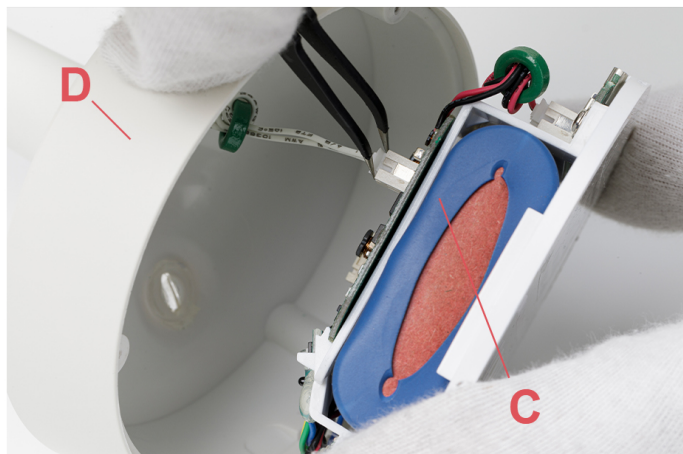
Fig.3

Remove the damaged base assembly with battery kit (C) from the lamp body (D).

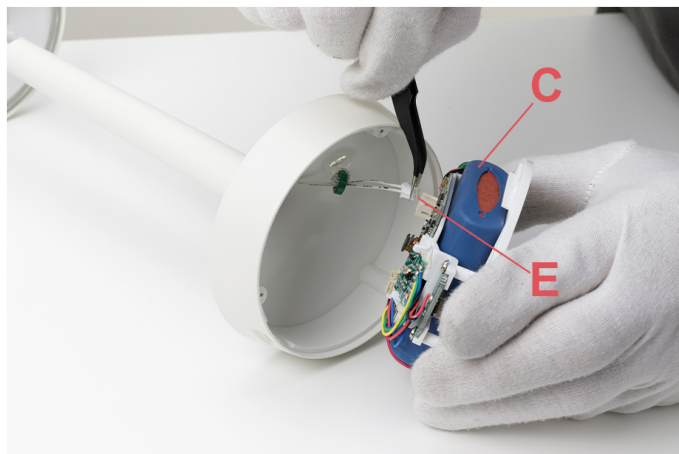
Fig.4

Disconnect the connector (E) using a small clamp from the battery kit.

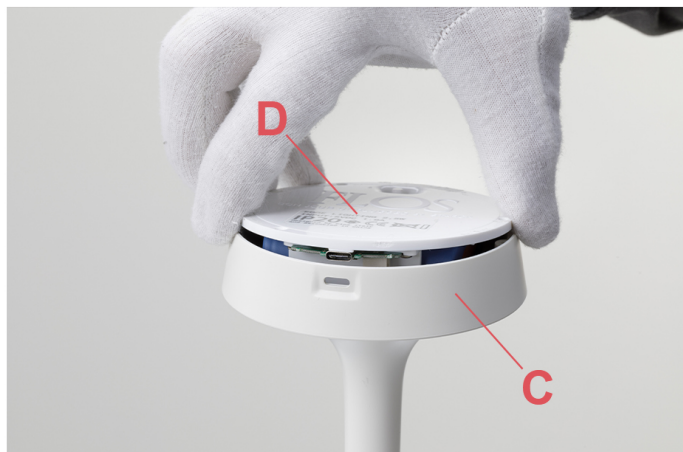
Fig.5

Assemble the base the new battery kit (C) to the lamp body (D).

Remarks!!! ensure that the USB port is in correspondence with the opening slot of the lamp body.

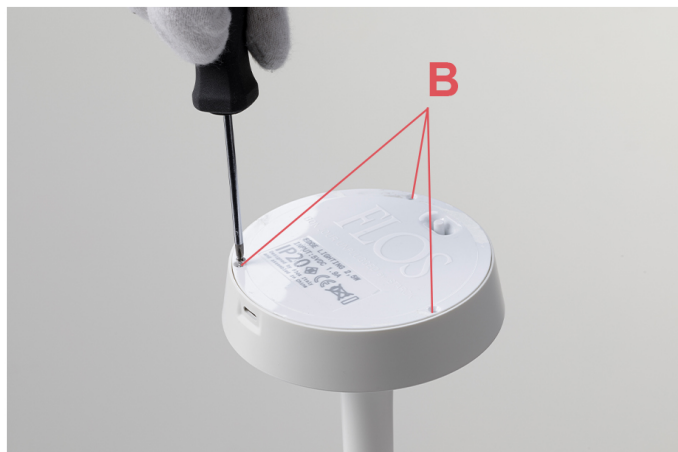
Fig.6

Fasten the three fixing screws (B).

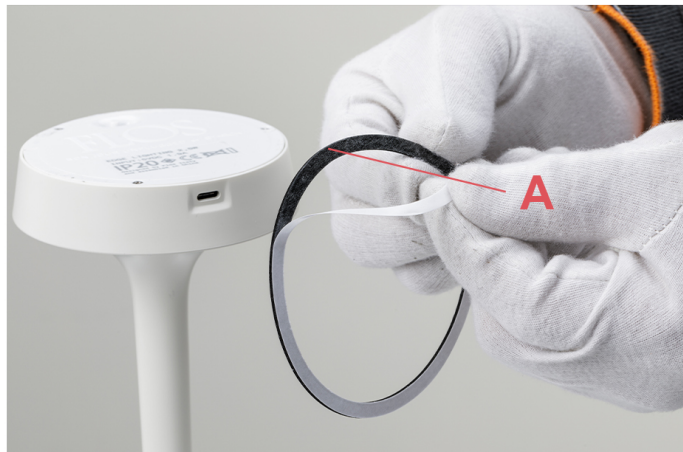
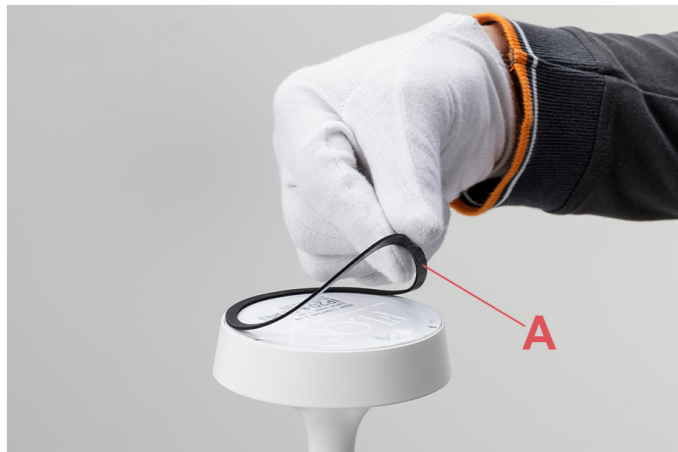
Apply the new rubber pad (A) underneath the lamp base.
